**AES PUERTO RICO, L.P.
Guayama, Puerto Rico**

**July 21, 2017 Site Visit
& Proposed Enforcement
Strategy**

**José A. Rivera BSCF
Lead Environmental Engineer
CEPD Clean Water Act Team**

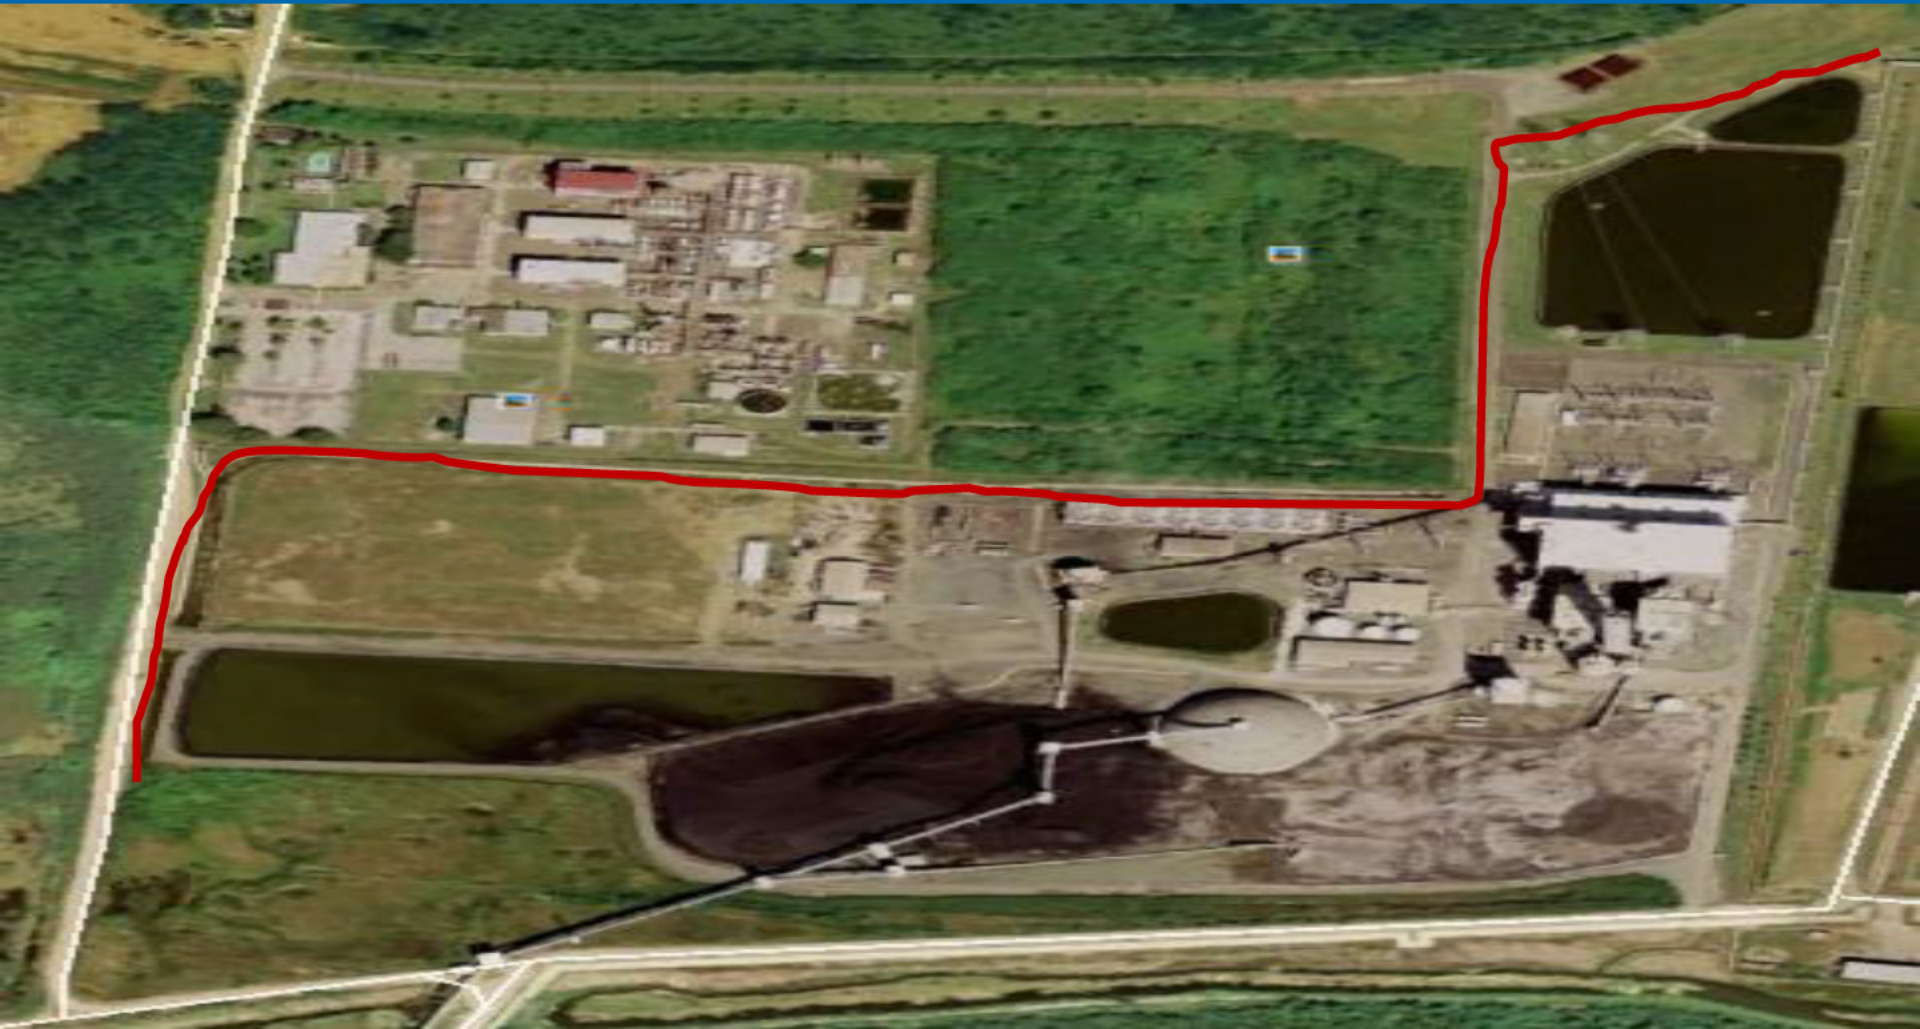
- Run-on from offsite and AES (non-regulated) site collected in concrete channel that discharges into wetlands

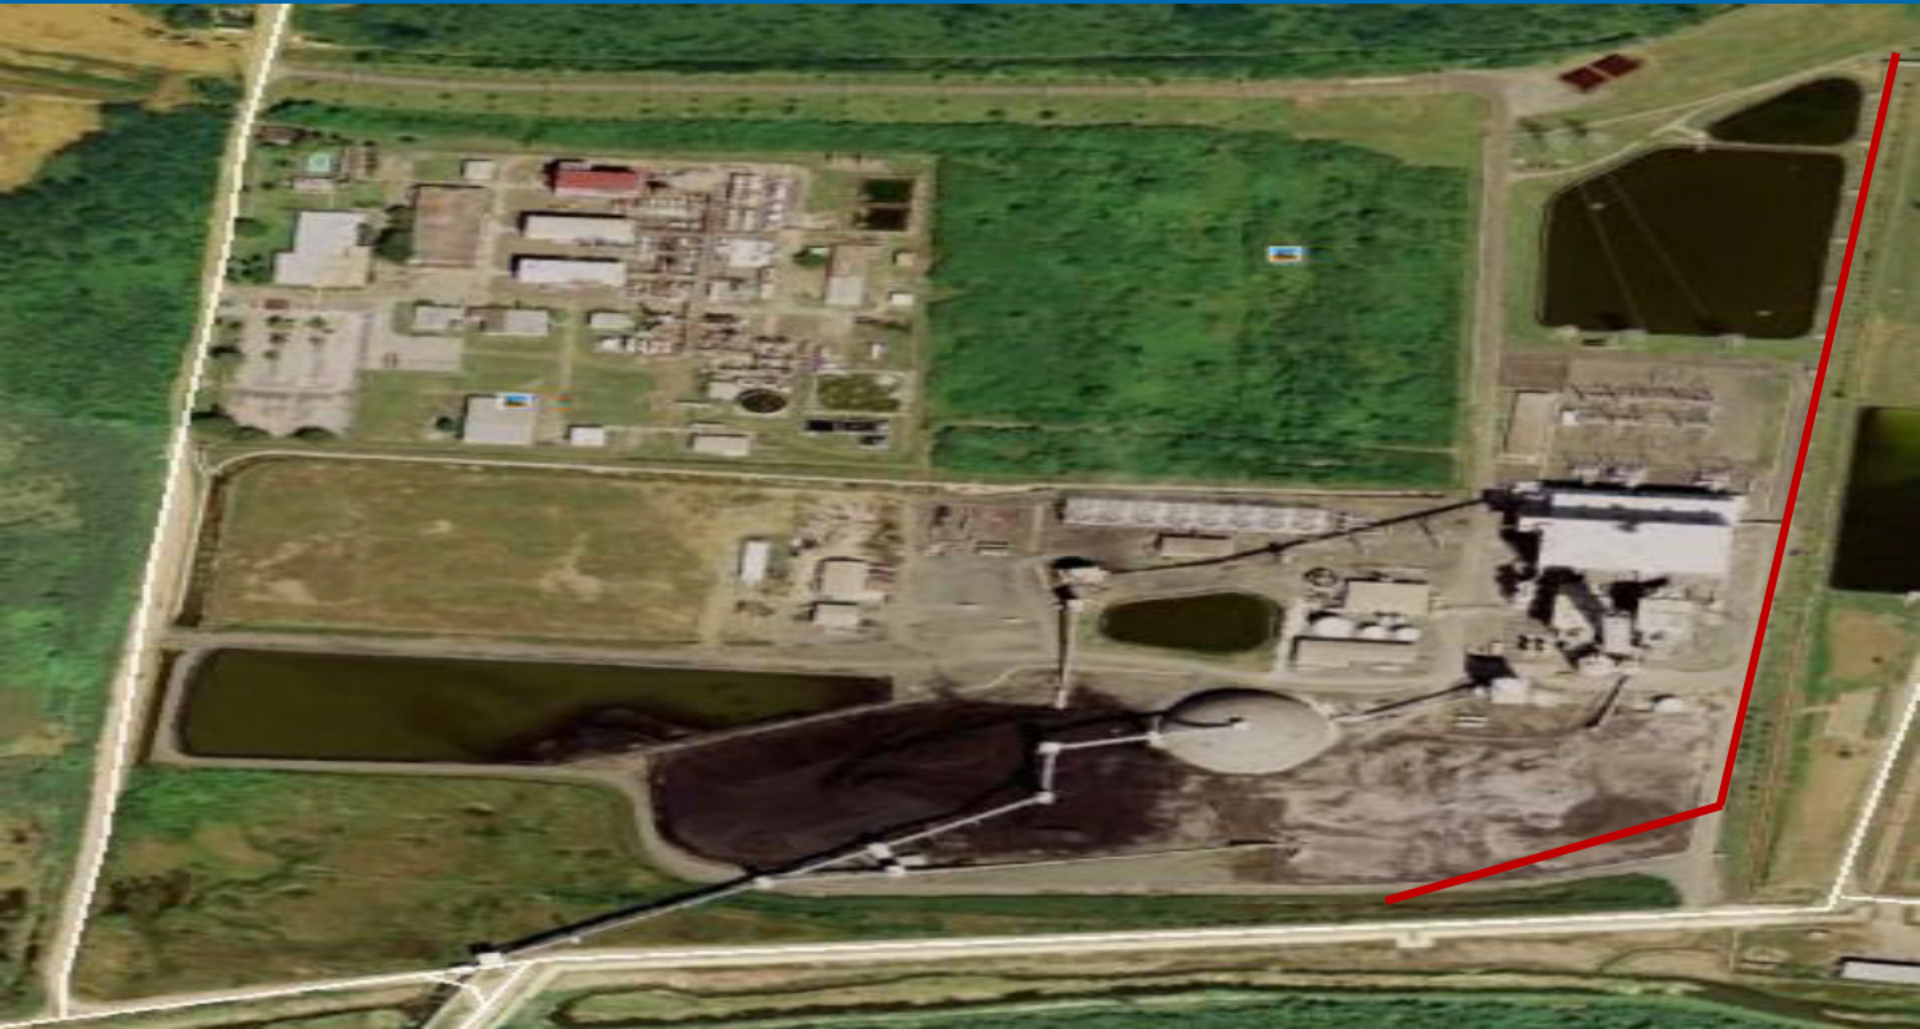
- Run-on from neighboring lands on north side is collected in underground pipeline that discharges into wetlands

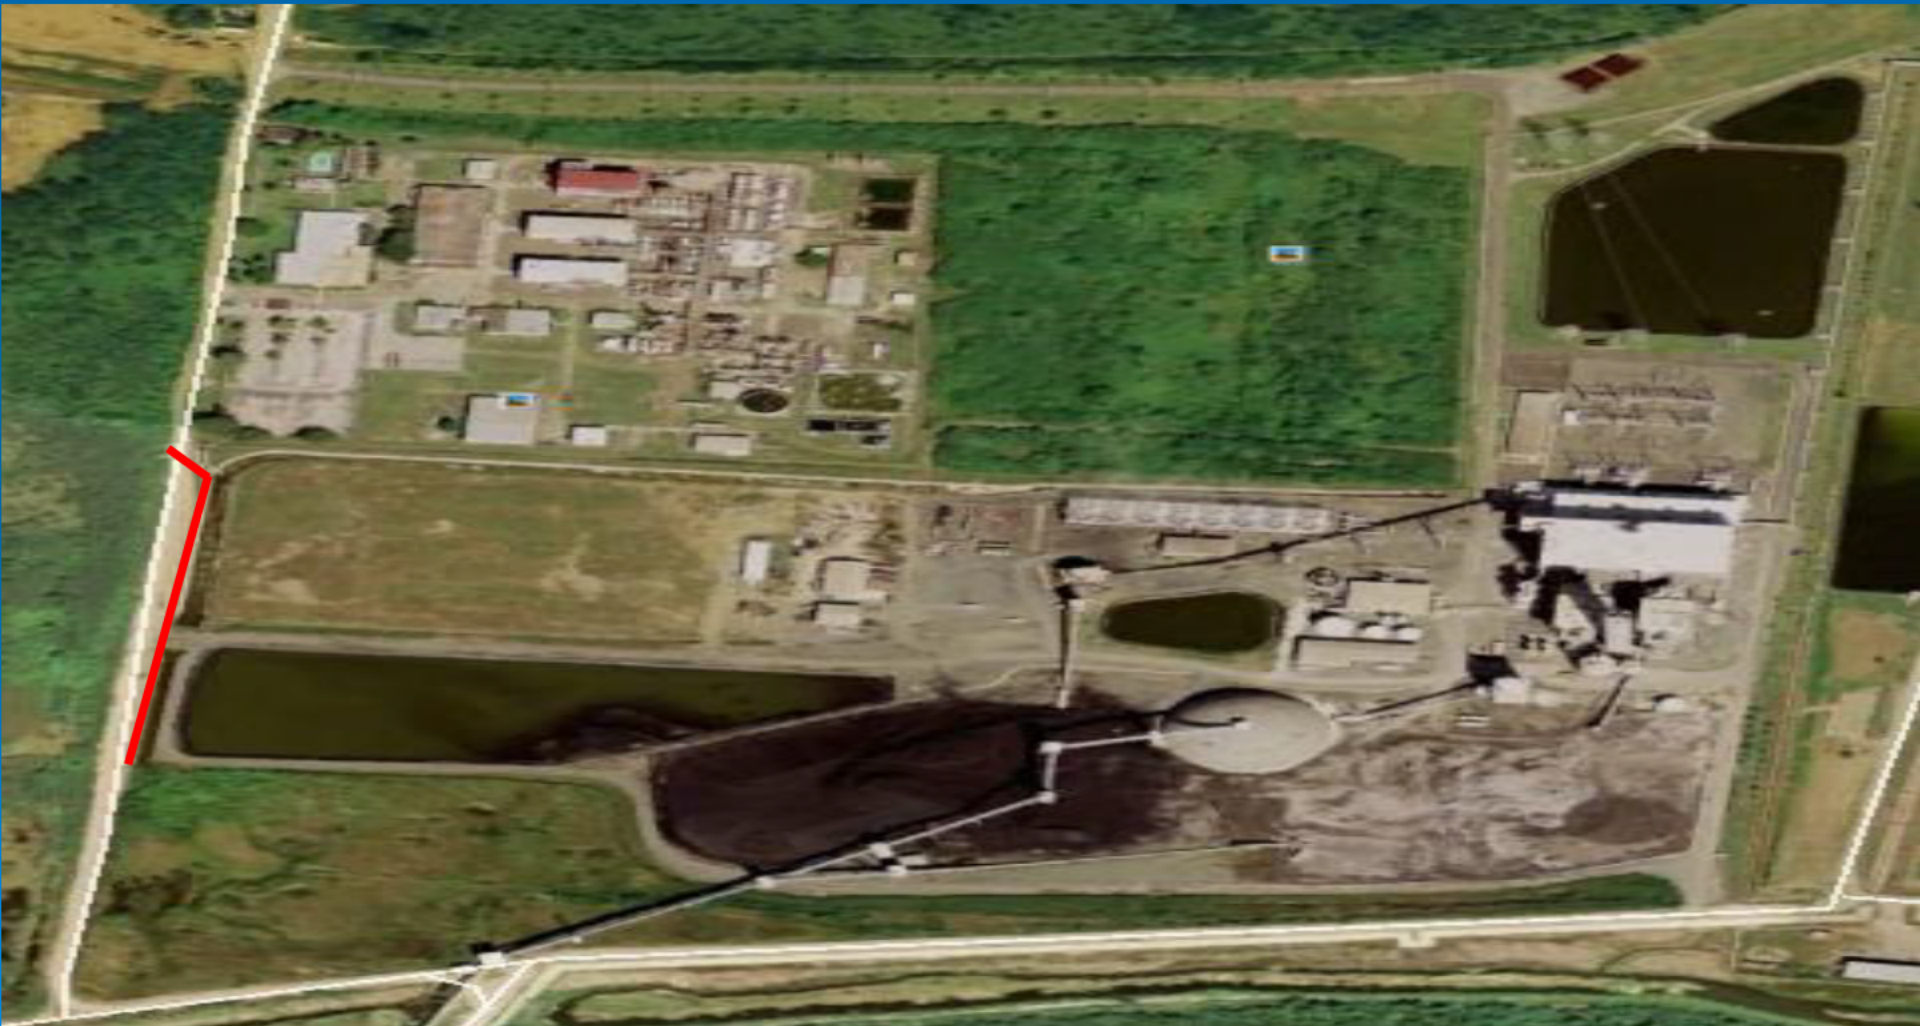
- Run-off from TAPI's facility is collected and discharged into wetlands side-by-side AES's Outfall 003.

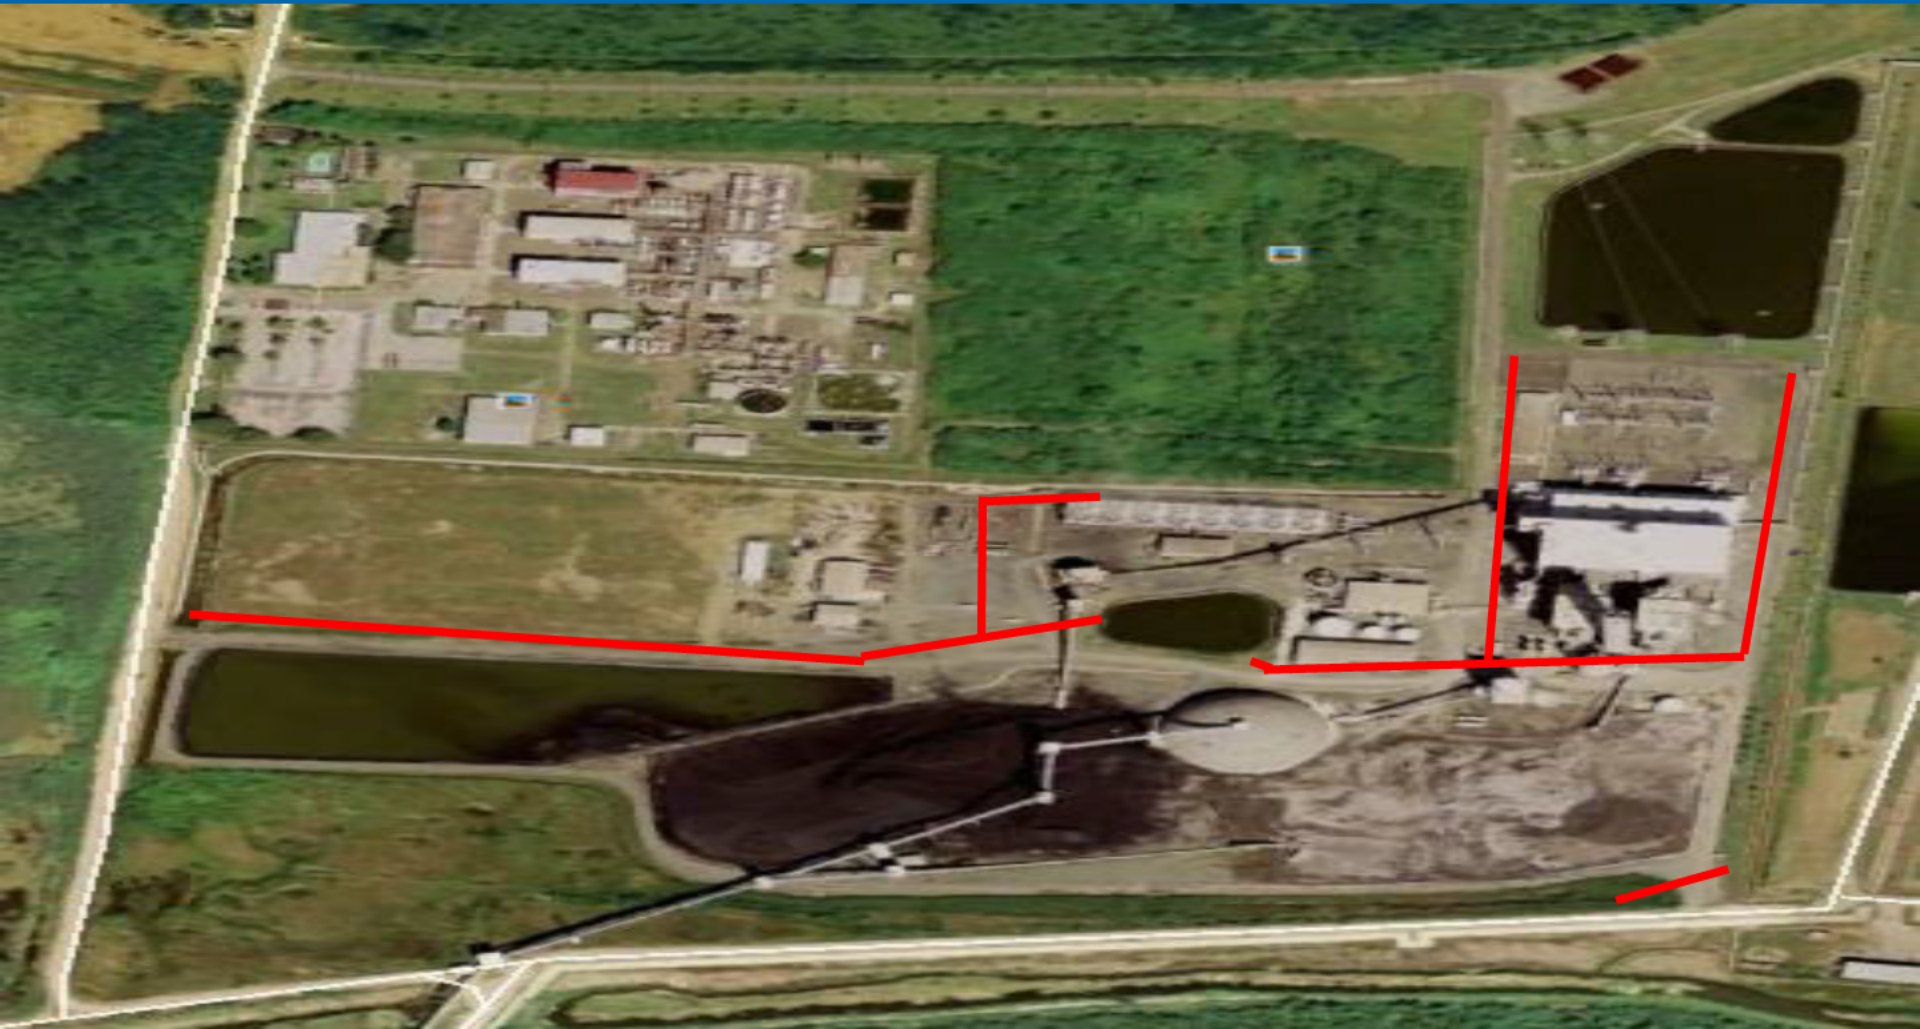
- AES' site stormwater runoff associated with industrial activity is collected in a stormwater collection and discharge system. AES reuses the runoff collected at SW Pond for water production prior to overflow discharge.

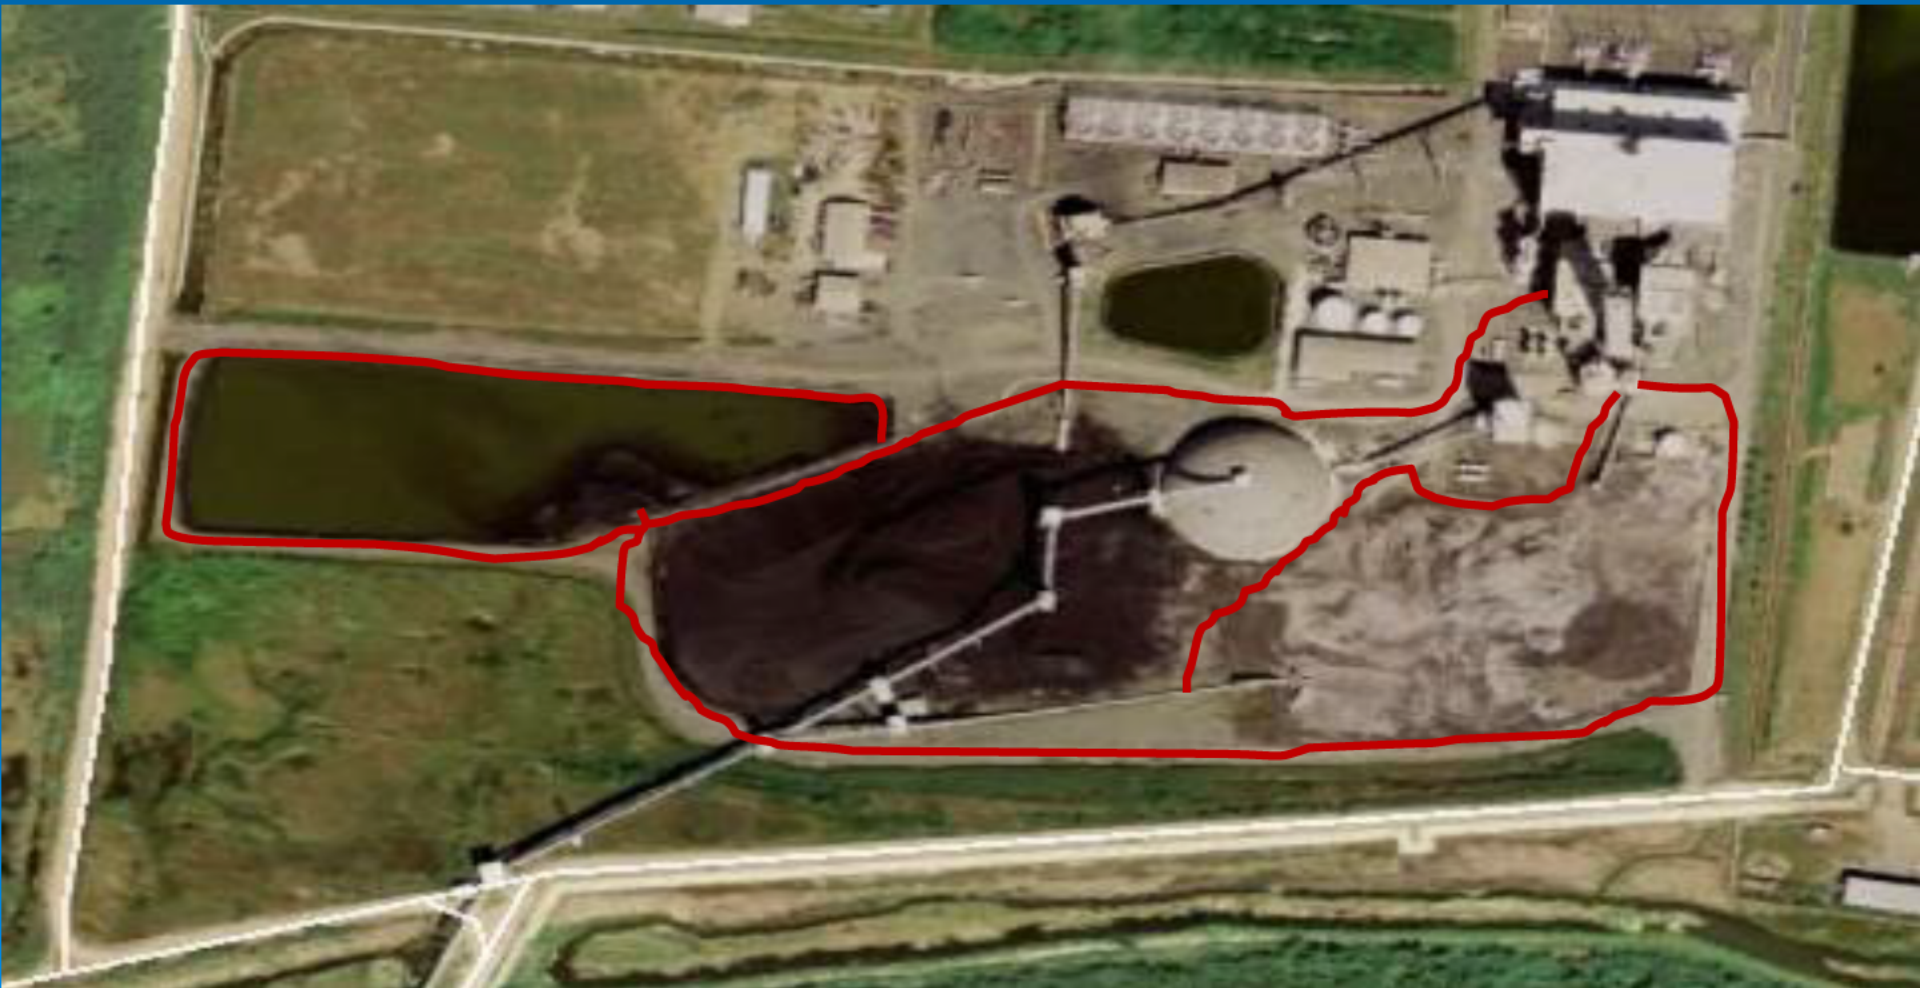
- Run-off (stormwater and process wastewater) from production and material storage areas is collected and conveyed into Coal Pile Runoff Pond through swales and channels. No discharge from this Pond into wetlands. All wastewater is re-used for water production and dust control.
